1969 and 1970 Lower Door Seals

Restoration Detail

MARCUS ANGHEL

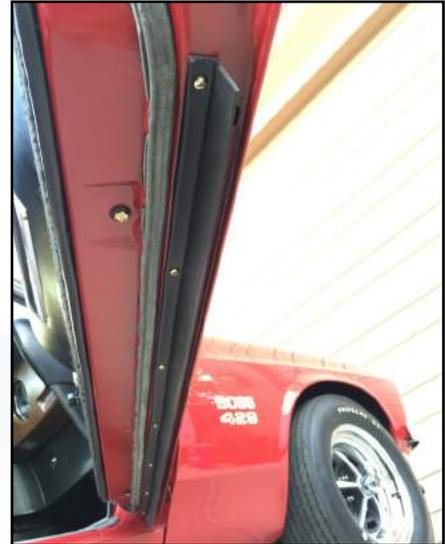
One of the most common missing parts on a 1969 Mustang or Cougar today is the lower weatherstrip seals on the doors. These seals were added to cars to keep dirt and moisture from entering but usually are missing or damaged even on original low mileage cars today. And because most people do not realize they are missing they are usually not put back on during the restoration process. This quick guide here will show some examples and the correct installation and mounting hardware for the seals.

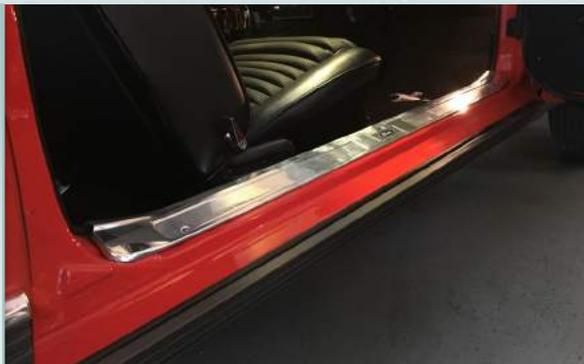
1970 Mach 1 shown here (courtesy of Scott Hollenbeck) with the rocker moulding trim and the rare rocker moulding filler strip. When ever there was any rocker moulding installed on a 1969 or a 1970 the weatherstrip seal would have been deleted.

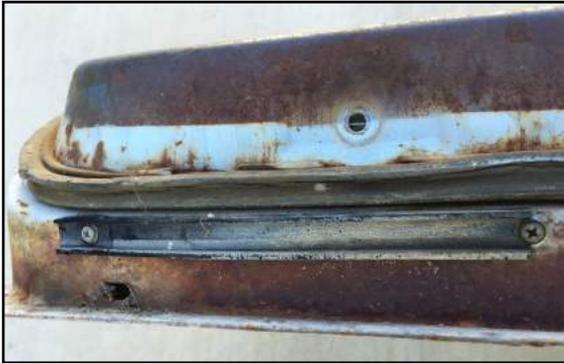
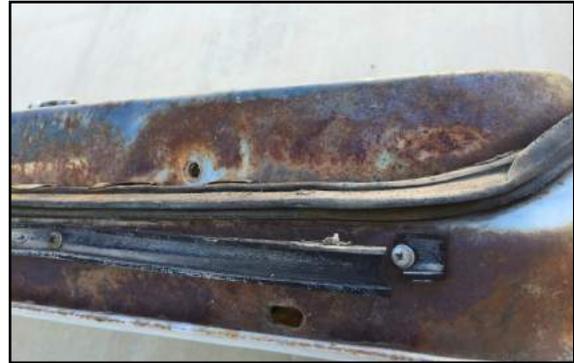
Original Door seals

This shows what's typically what's left on a car if it still has any of the door seal and the mounting hardware in place. The channel of the seal is still in place but the sweep is long been torn off or fell off.

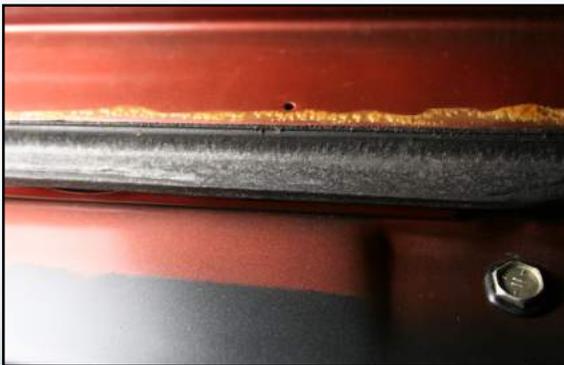
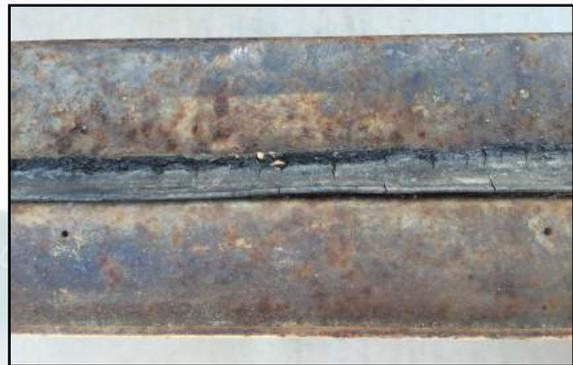
Original Pilot Holes

Many original doors still have the pilot holes visible where the seal would have been installed. Shown here is Bob Perkins original 1969 50 mile Mach 1 on the left and a 1970 door on the right. Note how small the pilot holes are.

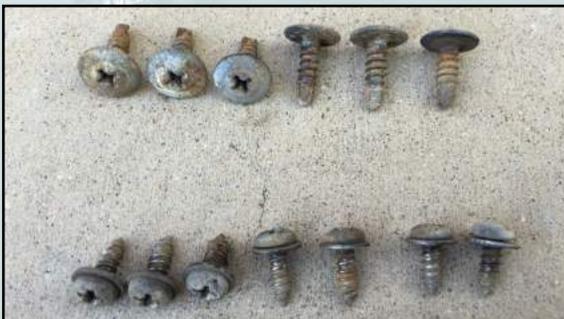
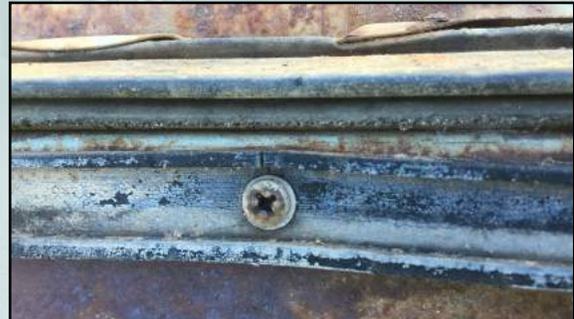
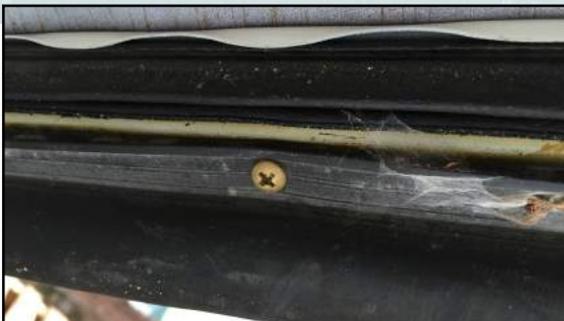
Original Mounting Hardware: The original mounting hardware that should have been used was specified as a 383379-S100 screw and washer in the assembly manual. Although this should have been used, other type screws were used as well as shown here. Typical finish seems to have been a zinc dichromate as pictured here on this original low mileage Boss429 on the left.

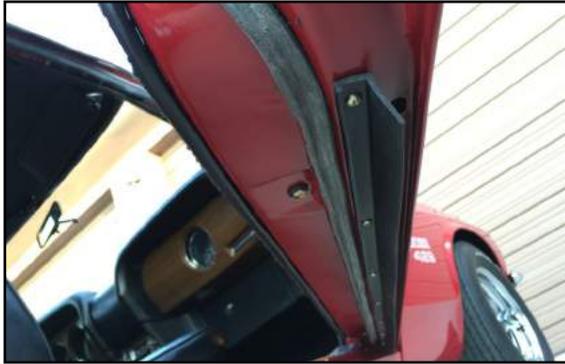
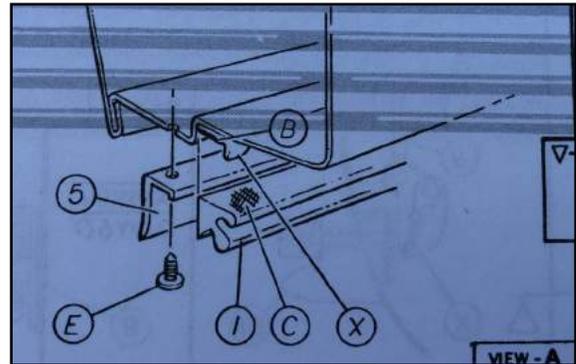
Installation

As shown in the pictures here make sure to remember to have the sweep of the seal on the outside. The seal can easily be installed backwards if not paying attention to this detail.

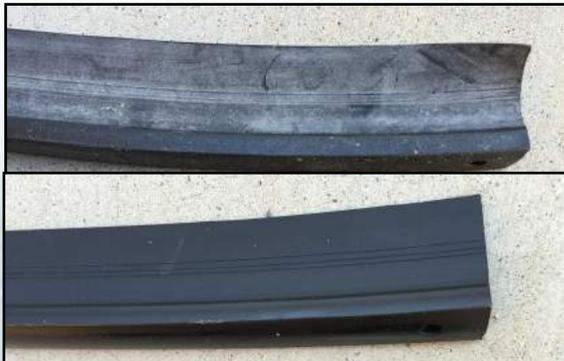
Side by side comparisons show the original NOS weatherstrip and the reproduction mentioned here. Reproduction has the rigid channel like the originals, pre-drilled holes and the grooves in the rubber like originals.

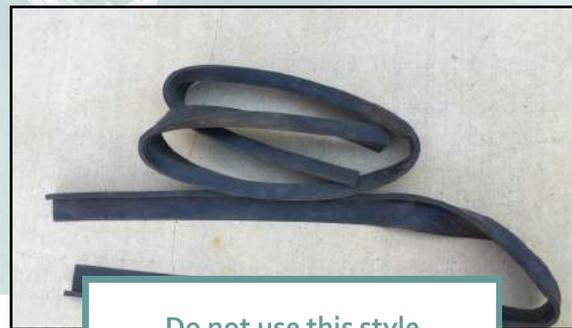
Do not use this style

Shown here is reproductions that have been for sale the last few years that you do not want to use. Notice how soft and flexible the rubber is has no pre-drilled holes. When installed on a car it does not fit or look correct because of this.
