Radiator Cooling Fan Shroud

Originally written by Marcus Anghel and edited by Scott Hollenbeck

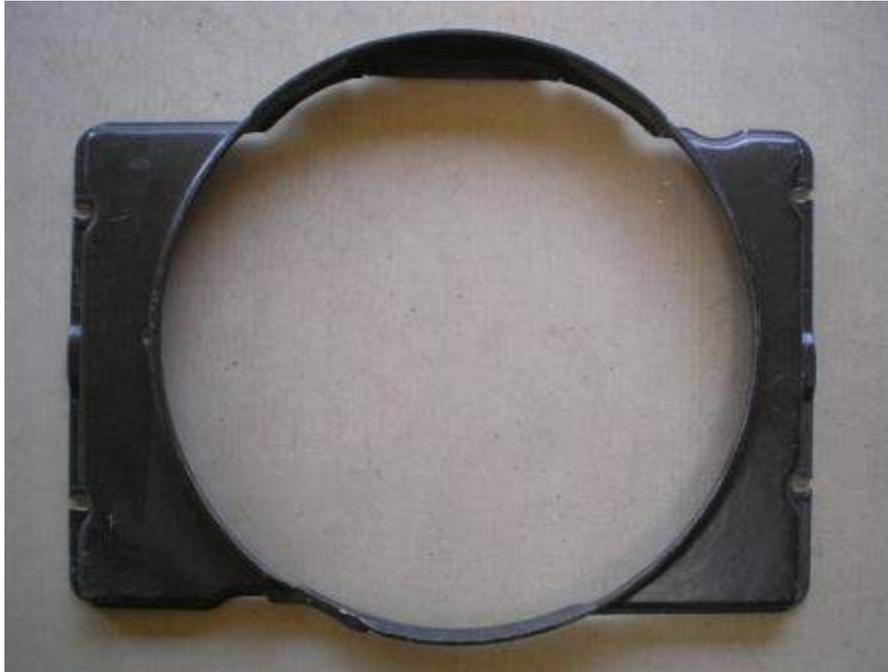
All 1968, 1969, and 1970 428-equipped Mustangs and Cougars used a 24-inch radiator fan shroud to concentrate air flow between the radiator and the cooling fan to make the cooling system run more efficiently. The fan shroud is designed to enclose the core area so that when the fan is spinning, air flows through the entire surface area. This greatly increases the radiator's ability to transfer heat.

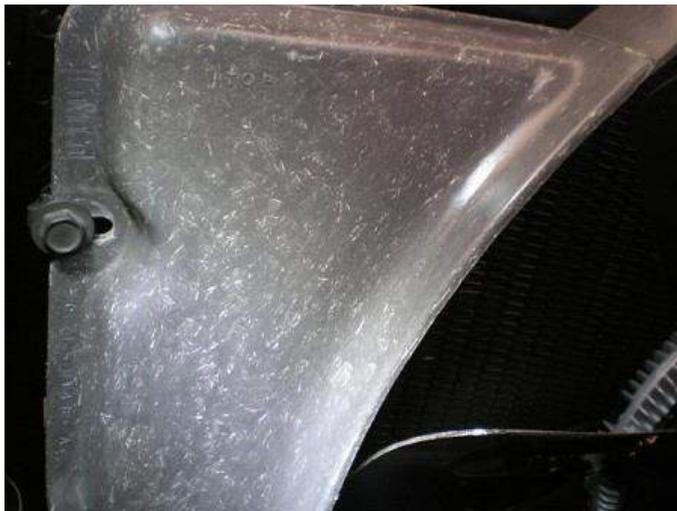
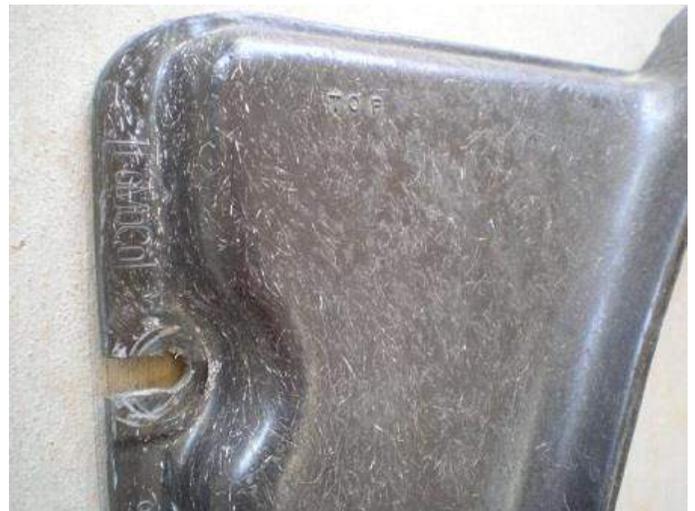
The C8ZE-8146-A version was the original design shroud and would have been installed on the 1968 428 equipped cars. It is simply identified with the word TOP molded in the top left and the edge molded with a large square FoMoCo logo, C8ZE-8146-A, and Barnum Bros. Fibre Co., Inc.

The major difference between the -A and -C version shroud is the reinforcement area around the lower radiator hose. The mold for the -C version was slightly changed by Ford probably due to breakage/warranty complaints and supplies more reinforcement in this area that is prone to cracking.

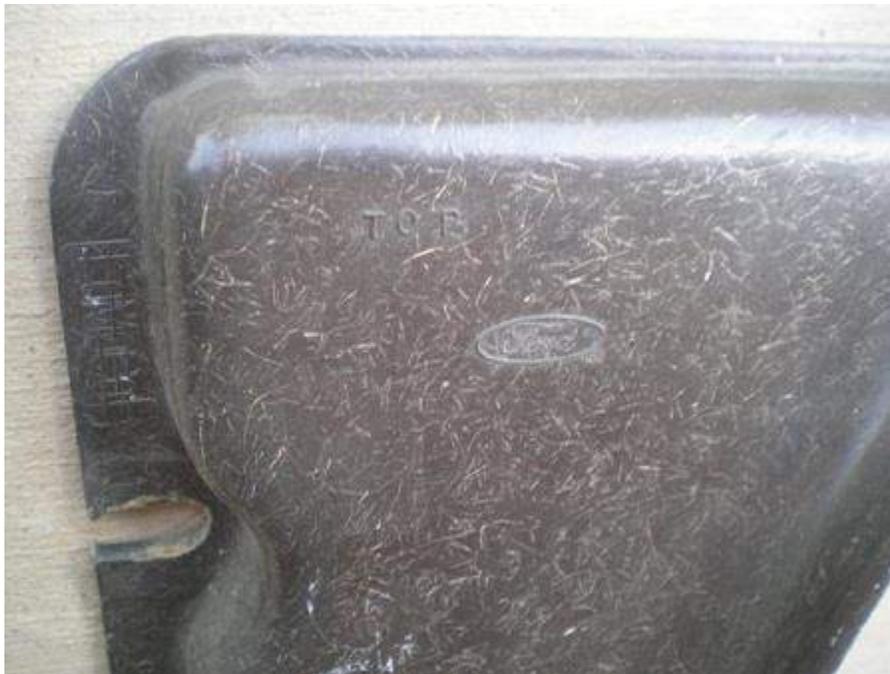
The second version, which appeared either in very late 1970 production or only as a service part, now has the oval Ford logo in the top left in addition to the word TOP. This period was when Ford was phasing out the block FoMoCo to the oval Ford logo. The edge is molded with a large FoMoCo that is now lined out, C8ZE-8146-C, and Barnum Bros. Fibre Co., Inc. The texture would still have been a horse hair texture.

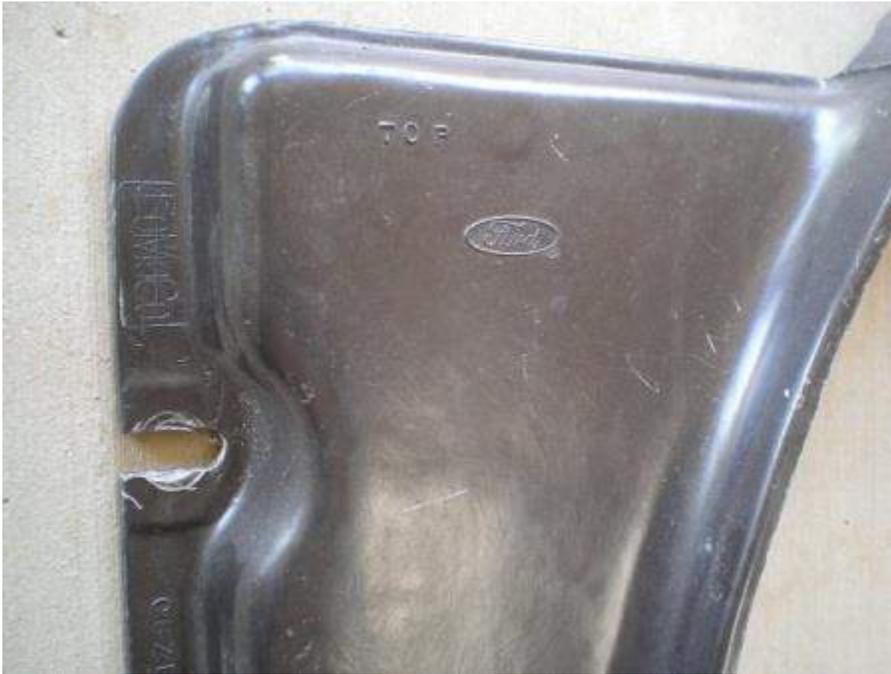
The third/service version, which is the service replacement which was sold at Ford dealerships up into the 1990s, has the oval Ford logo in the top left and the word TOP. The edge is molded with a large FoMoCo that is lined out, C8ZE-8146-C, and Barnum Bros. Fibre Co., Inc. The texture of the fiberglass on these fan shrouds now is a smooth texture with no glass fibres visible anymore and the shroud feels slightly more flexible.

Fan shrouds with a lined out FoMoCo on the side are considered service replacements as they would not have appeared in regular assembly line cars, except possibly on some of the last built 1970 Cobra Jets.

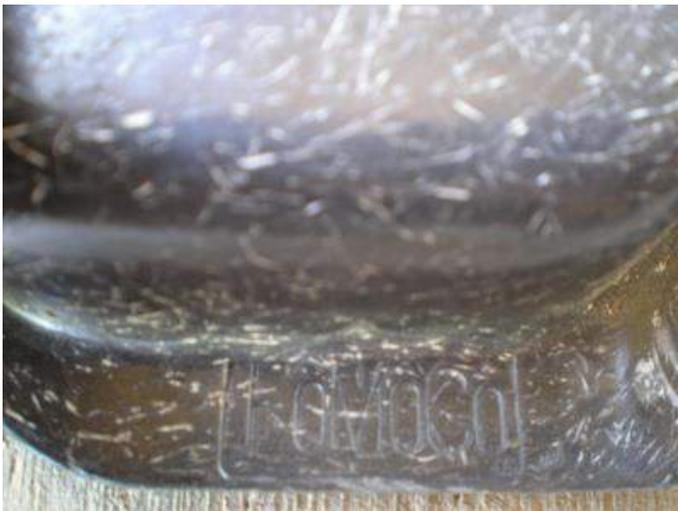
C8ZE-8146-C Early Logo

The first version, which probably appeared in early 1969 models, is identified with the word TOP molded in the top left and the edge molded with a large square FoMoCo logo, C8ZE-8146-C, and Barnum Bros. Fibre Co., Inc. The texture is commonly referred to as a horse hair texture, which has numerous large glass fibres as opposed to later versions which are smooth.

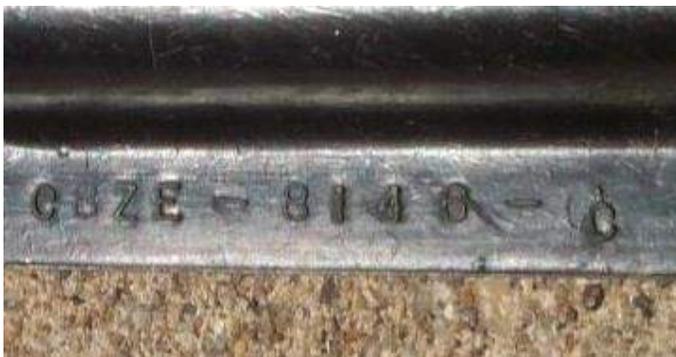
C8ZE-8146-C Engineering Number

Here's a closer view of the -C engineering number and "Barnum" markings.

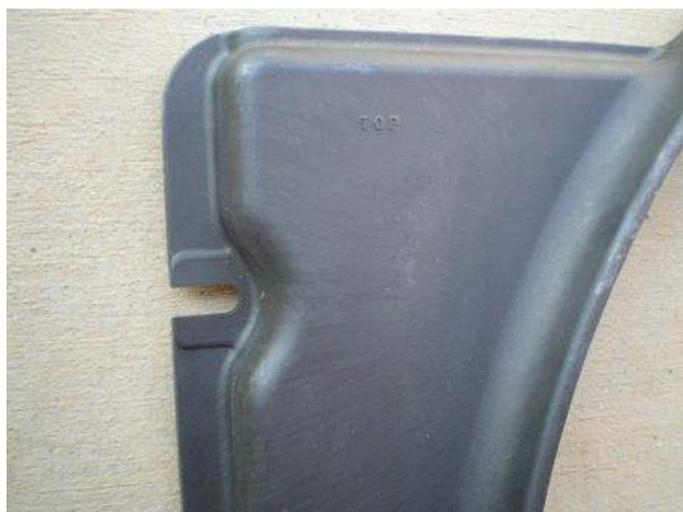
Reproduction Shroud Front Marking

The current reproduction version available today is manufactured by Daniel Carpenter Mustang Reproductions and sold through various resellers. The shroud seems to be an exact copy of the -C version with no FoMoCo markings/logos except for the word TOP. The back side has DCMR Mfg. USA.

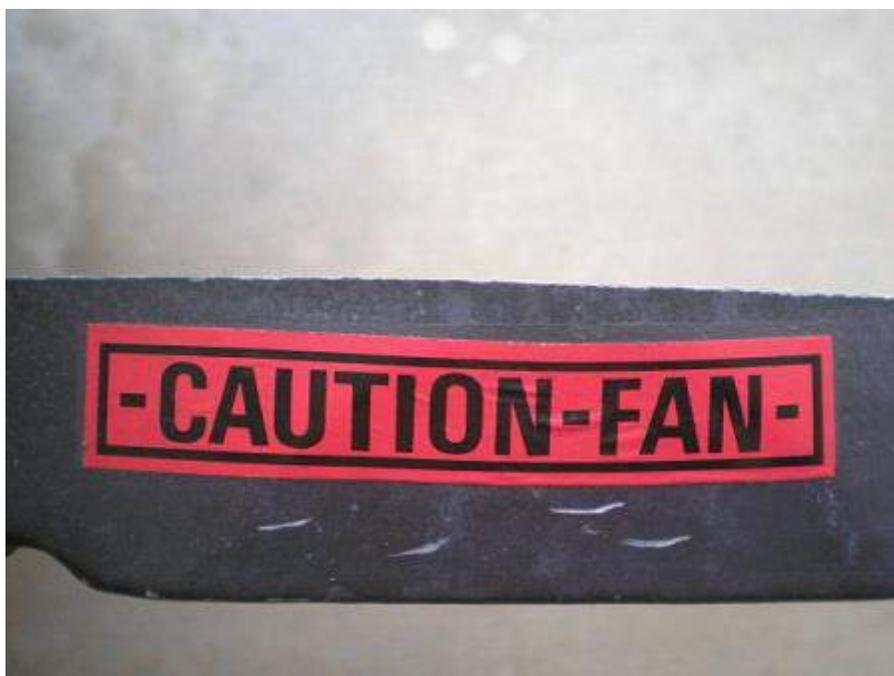
One important note: The only fan shrouds that ever came with a "Caution Fan" sticker were the service replacements. This may have started in the mid-1970s. This sticker was not placed on the fan shroud for factory assembly during the 1968 to 1970 model years. There have been discussions that they may have been placed on cars by the dealer when the vehicle came in for service at a later date, possibly related to a service bulletin.
