1969 and 1970 Mustang Hood Lip Moulding

MARCUS ANGHEL

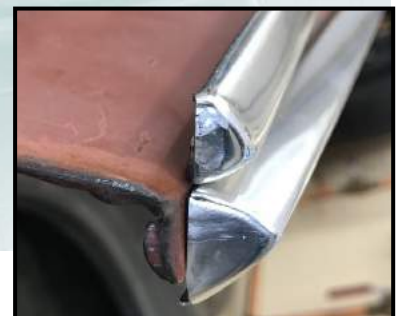
1969 and 1970 hood lip moulding shown side by side for comparison. The smaller one (above) is for a 1970.

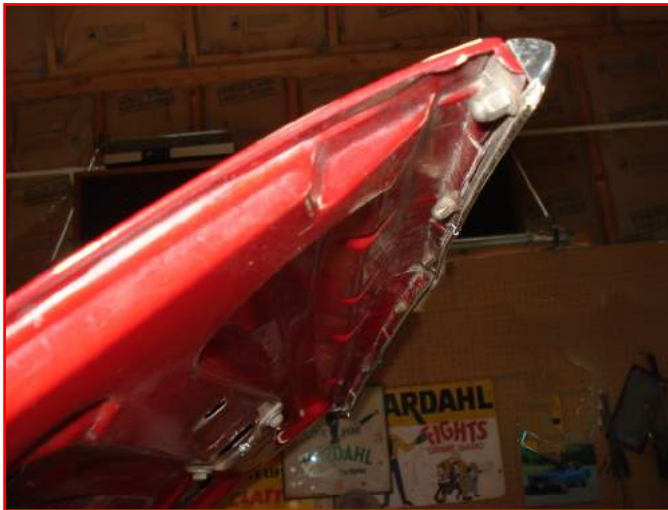
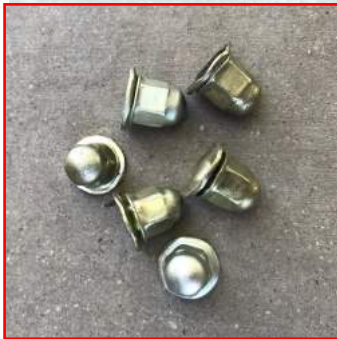
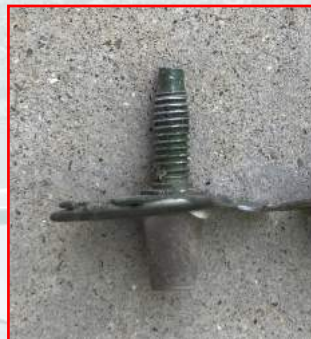
1969 Detail

Pictures above show the installed hoop lip moulding for 1969 with the correct hardware as well. Retainer nuts are zinc dichromate (gold) and as shown with correct length and style retainer clip.

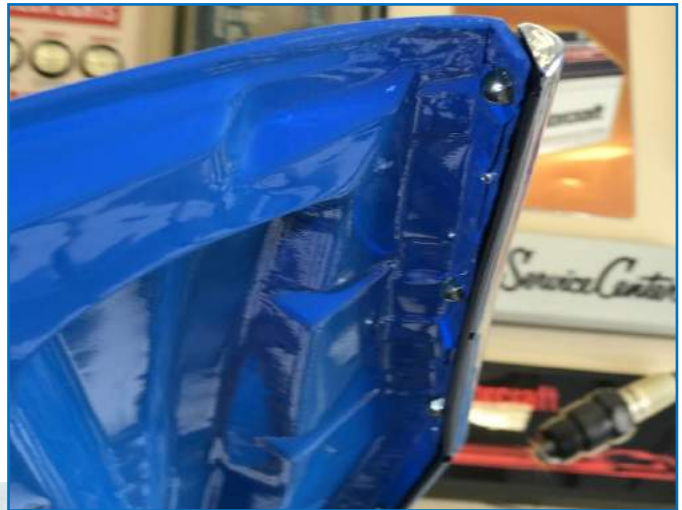
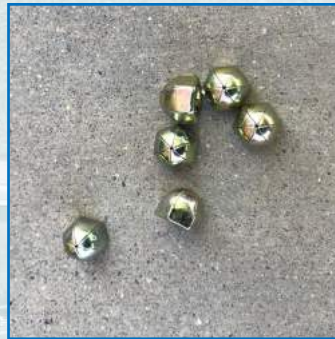
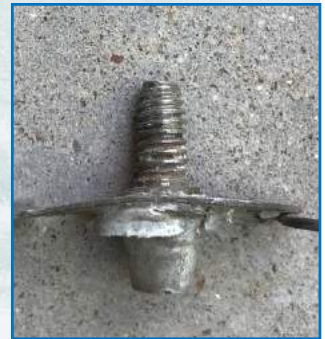
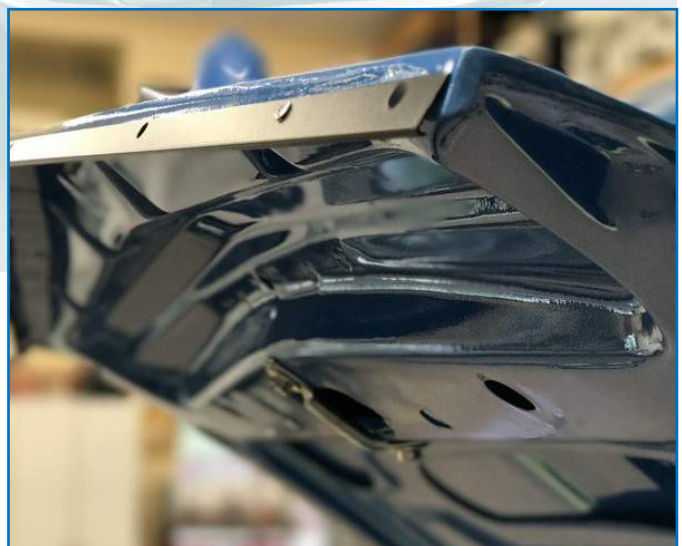
1970 Detail

Images to the right show the 1970 hood lip moulding installed and the corresponding clips and retaining nuts that are also zinc dichromate (gold). Also shown is the front moulding support that is only used on a 1970 and held in place to the hood with three rivets. Note the 1969 and 1970 hardware is completely different and easy to spot the differences once installed and hood is open. And the actual hood lip moulding itself is completely different on the two years.

In addition to the difference in the mouldings, in 1970 the Mustangs used an additional "hood front moulding support" that was riveted to the outside of the front of the hood. The excerpt below (from the Master Parts Catalog) and the photos on the next page show this how this piece was attached with three rivets. It was originally galvanized and then painted black, but because of the galvanized finish the black paint would usually flake off, but the correct restored finish is a black semi gloss.
