1969-1970 Mustang Horns (and the oil cooler option)

M A R C U S A N G H E L

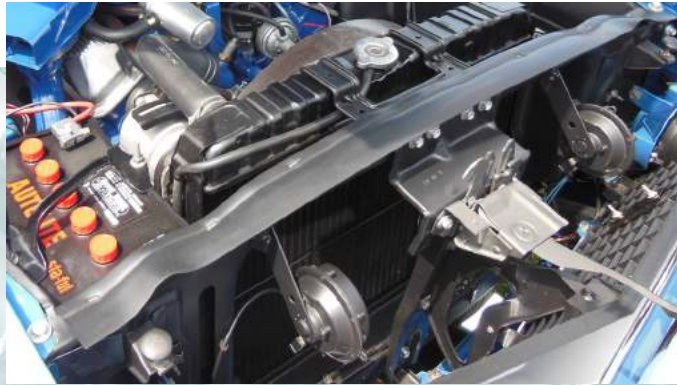
All 1969 and 1970 Mustangs, Boss's, Shelby's and Cougars used the same high and low pitch horns mounted to the radiator support. The horns were always installed in pairs and sounded together to produce a more perceptible sound rather than two horns of an identical frequency. The 69 and 70 style horn, including the mounting bracket assembly, was never actually serviced by Ford as such. Instead Ford sold a universal horn assembly kit that included an adjustable bracket and could be used on all the different models of cars. The assembly line correct style original horns are shown here below:

Low Pitch—Passenger side

High Pitch—Drivers side

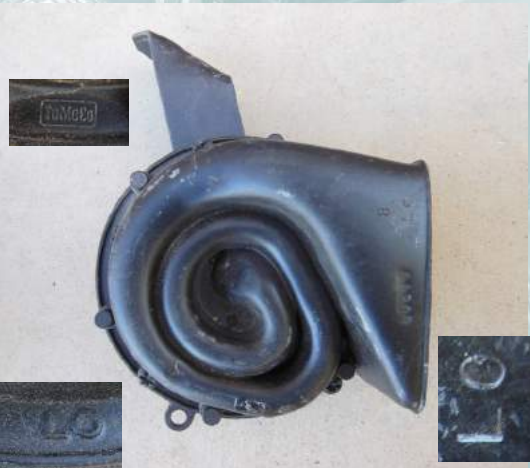
Low Pitch horn: Identified by the LO stamping on the side of the die cast housing and the edge of the bellmouth. Also has a single FoMoCo stamp on the edge of the housing. These horns have a longer coiled tube length to create a lower horn pitch.

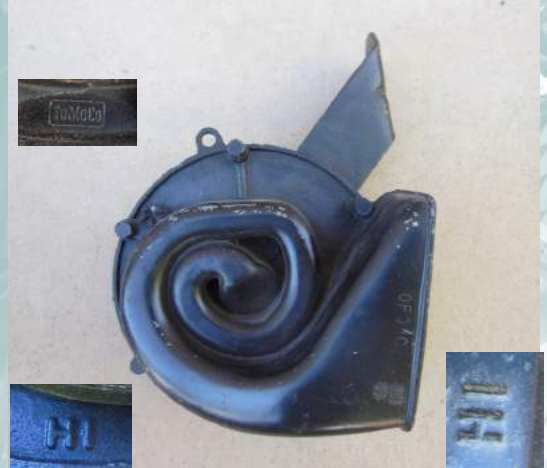
High Pitch horn: Identified by the HI stamping on the side of the die cast housing and the edge of the bellmouth. Also has a single FoMoCo stamp on the edge of the housing. These horns have a shorter coiled tube length to create a higher horn pitch.

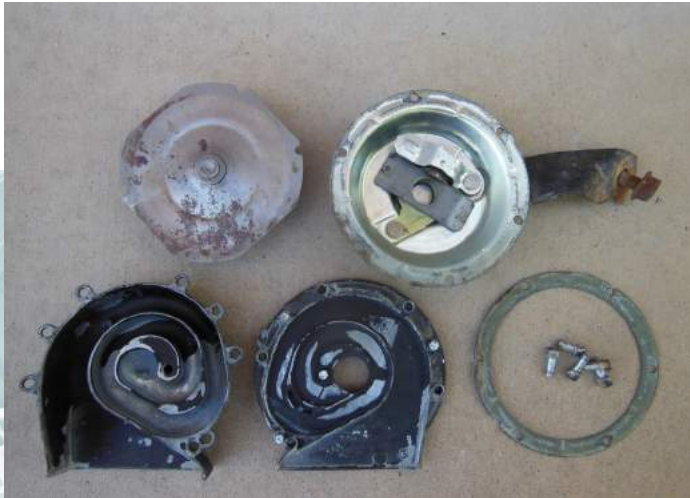
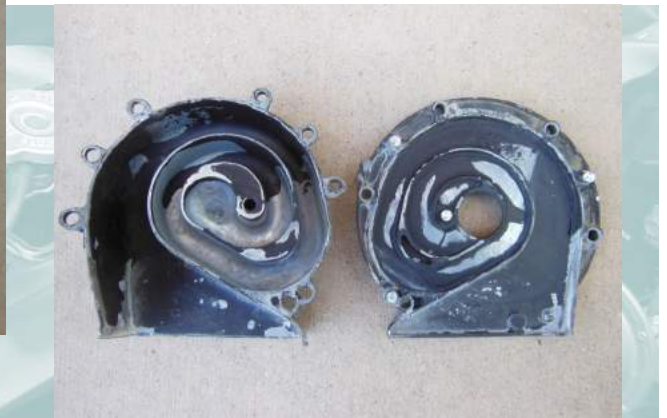
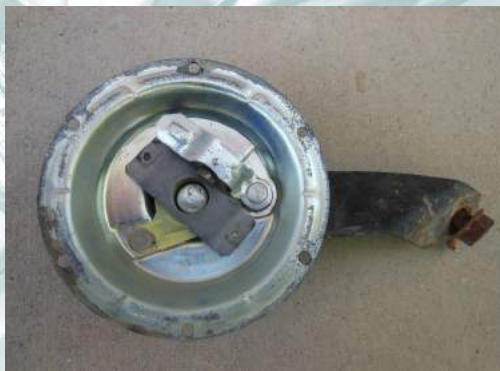
Pictures here show what a horn looks like that is completely opened up. The pieces consist of three diecast sections, a steel diaphragm, electromagnet, contact points, gaskets, and rivets. When voltage is applied the electromagnet is activated which oscillates the diaphragm. This opens the contact points which de-energizes the electromagnet and relaxing the diaphragm. This happens hundreds of times a second which then blasts thru the megaphone housing creating the sound we hear.

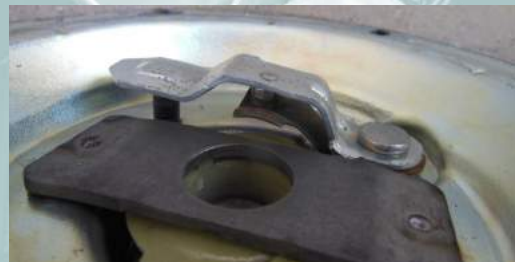
Electromagnet and contact points

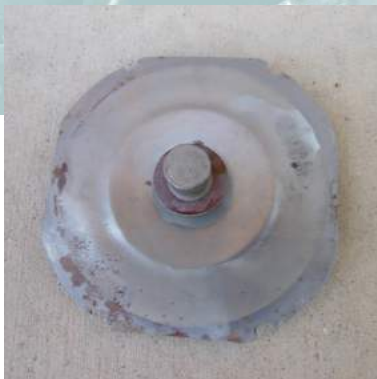
The steel diaphragm

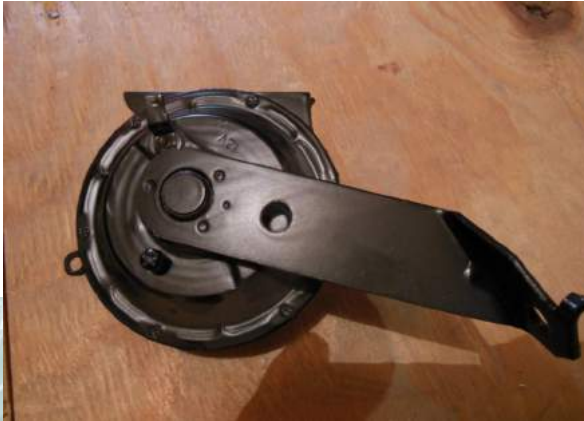
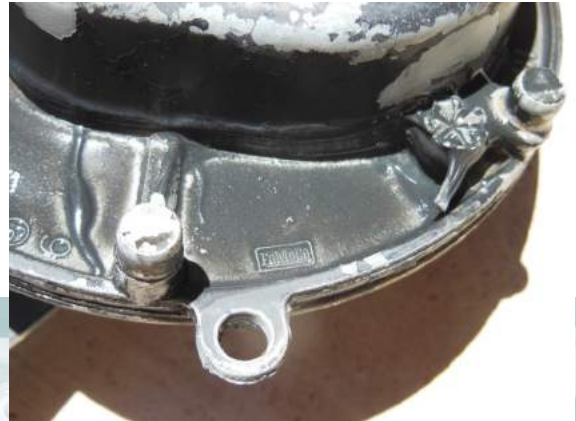
Paint: All horns were originally dipped in paint (not sprayed) and although not easy to spot can be seen in some of the runs that originals have.

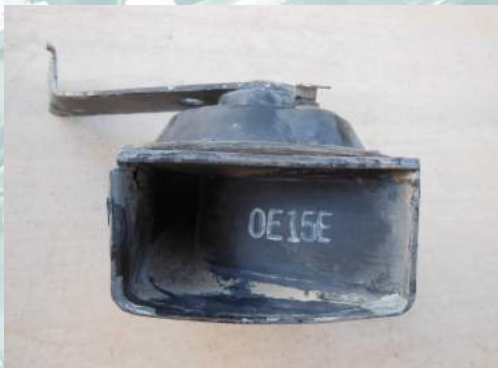
May 15, 1970

Date Codes: All horns during this time period have date codes that were either stamped into the housing near the edge of the bellmouth or on rare occasions were ink stamped just inside the bellmouth.

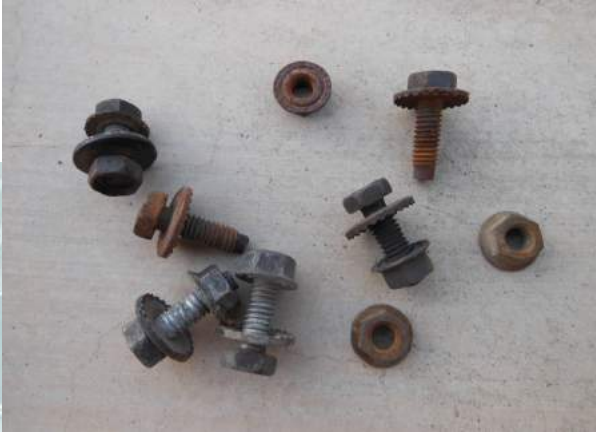
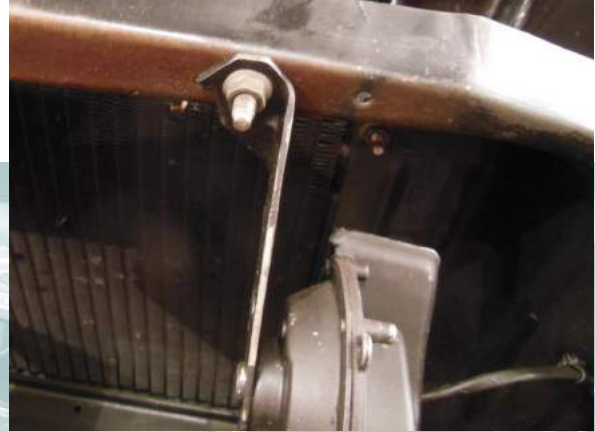
Mounting hardware: For standard horn installation (no oil cooler) the assembly manuals for 1969 and 1970 both show the bolt being installed from the back of the radiator support and the lock nut installed from the front. Although this is what is shown, this was not always what was done on the assembly line. It could have been installed either way. Notice that the bolts have serrated washers to help cut into the metal for better grounding of the horns.

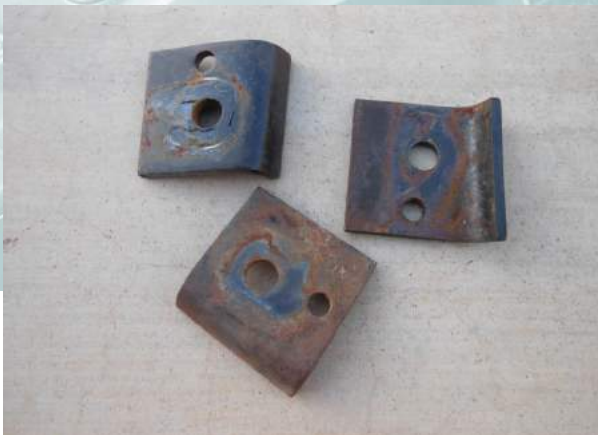
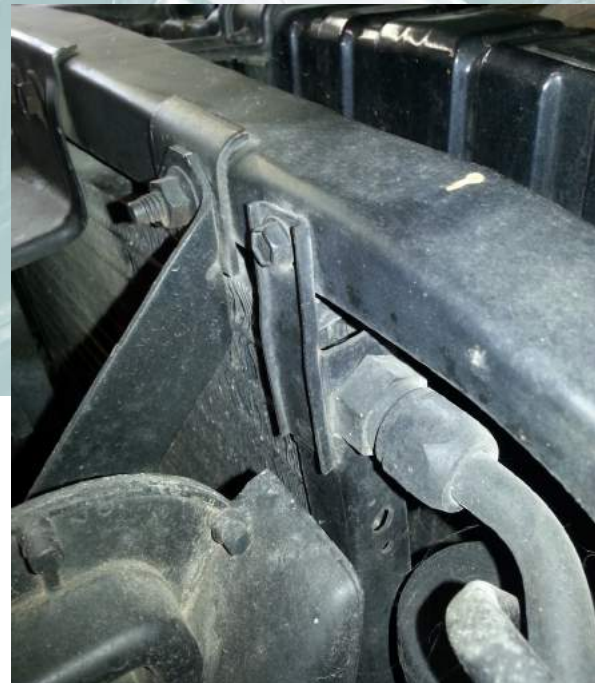
Horn Spacer: Only used on cars with air conditioning this spacer would be used on the drivers side for clearance issues with the condenser.

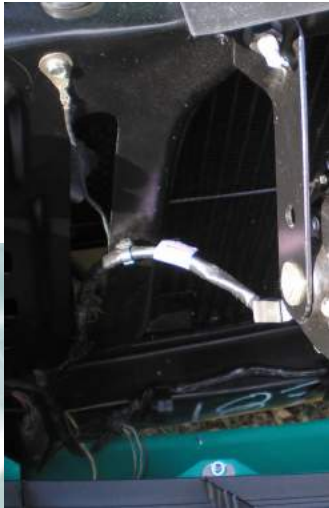
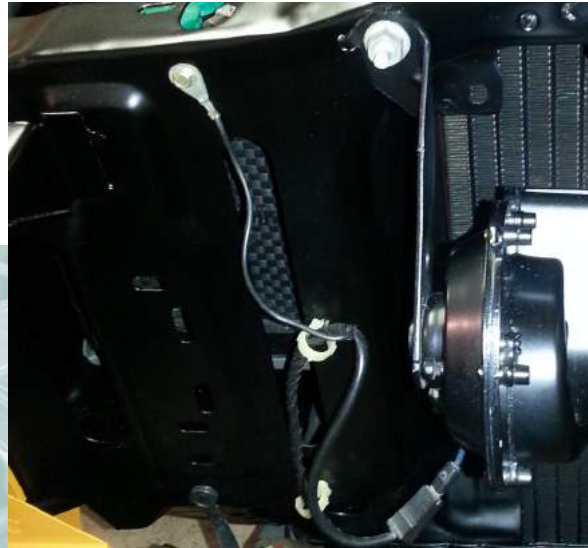
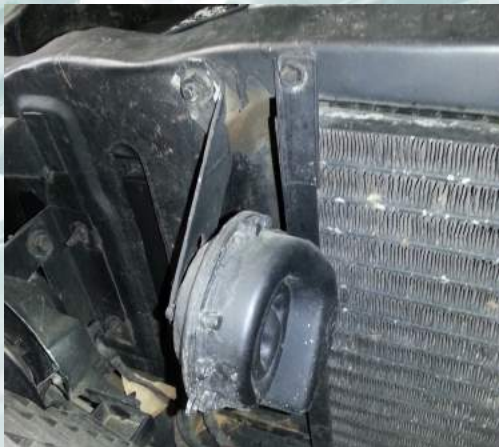
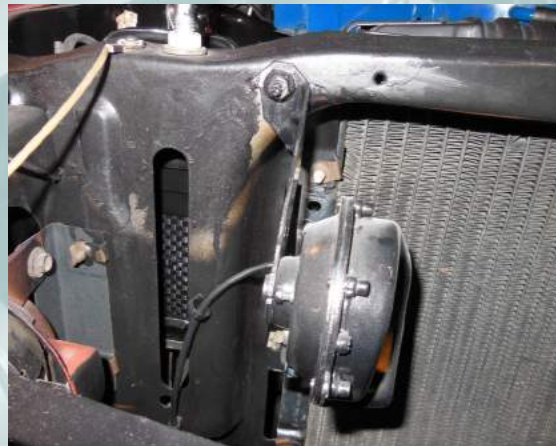
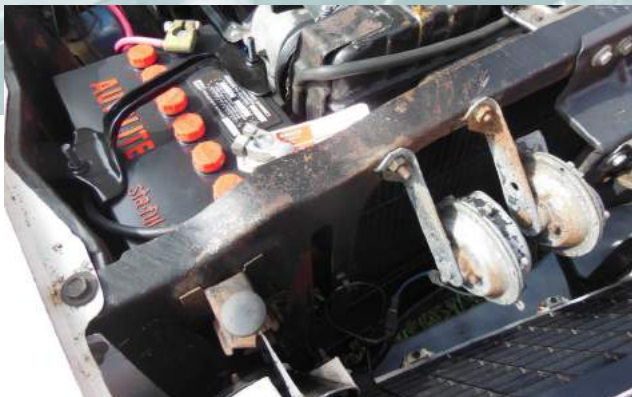
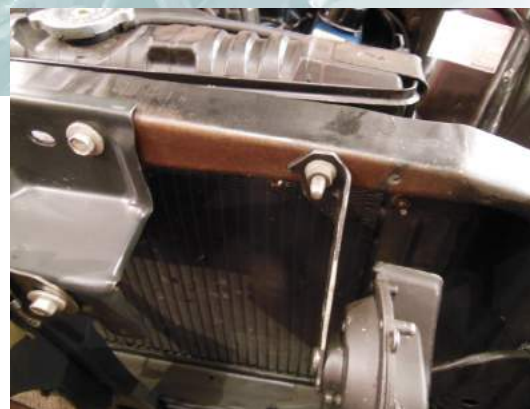
Grounding and Paint: At some point in 1970 production Ford added an extra grounding point to the wire harness in the horn area. Additional pictures below also show some original paint cars where the radiator support area was lightly painted and then black paint brushed on after the horns were installed. This would help with grounding issues related to the horns.

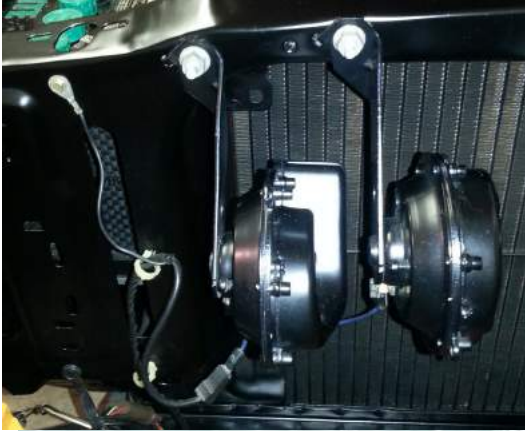
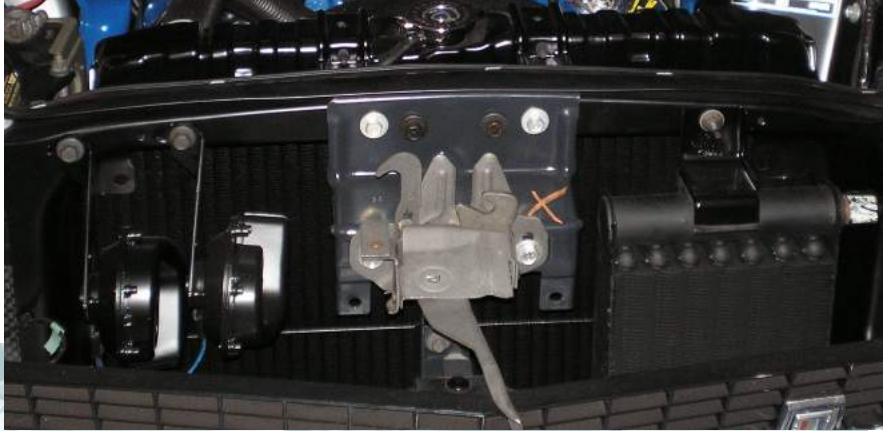
Oil Cooler Option: The radiator support would be modified at the factory to allow the horn to be re-located on these cars to make room for the oil cooler (if so equipped). Available on certain Mustang, Cougar, and Shelby models with a 428, and during 1970 the Boss 302 that were equipped with the oil cooler, all 1969 Boss 302's and all Boss 429's.

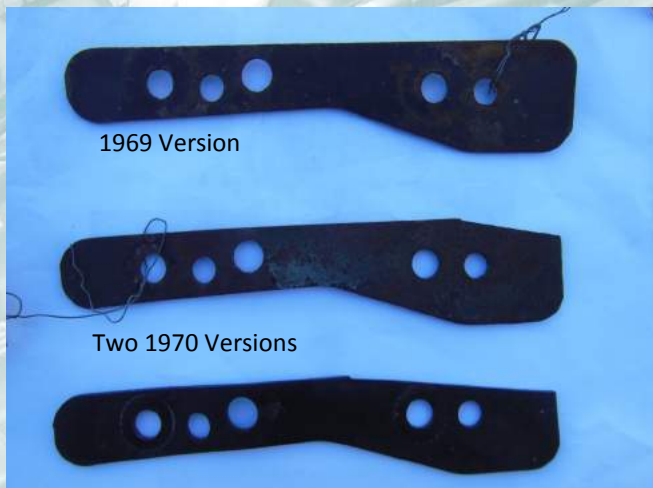
Horn Reinforcement Bracket: This bracket should have been placed behind the radiator support to strengthen the area where the horns were being mounted, however not every car had them installed from the factory. Three different styles are shown below starting with the first generation bracket used in 1969. Then with changes in the radiator support and possible inference with the hood locks the bracket was modified in 1970 by cutting the edge. Ford assembly manuals confirm this change.

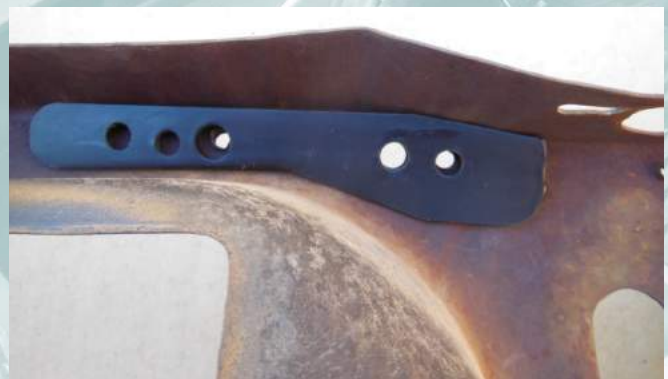
1970 radiator support to show clearance issues.

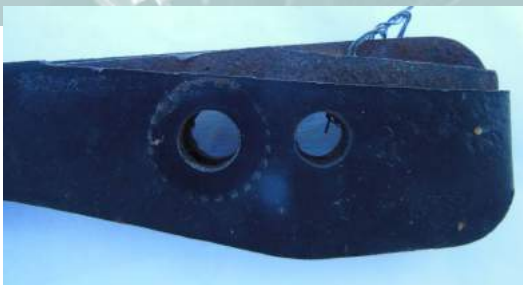
The three different versions shown side by side

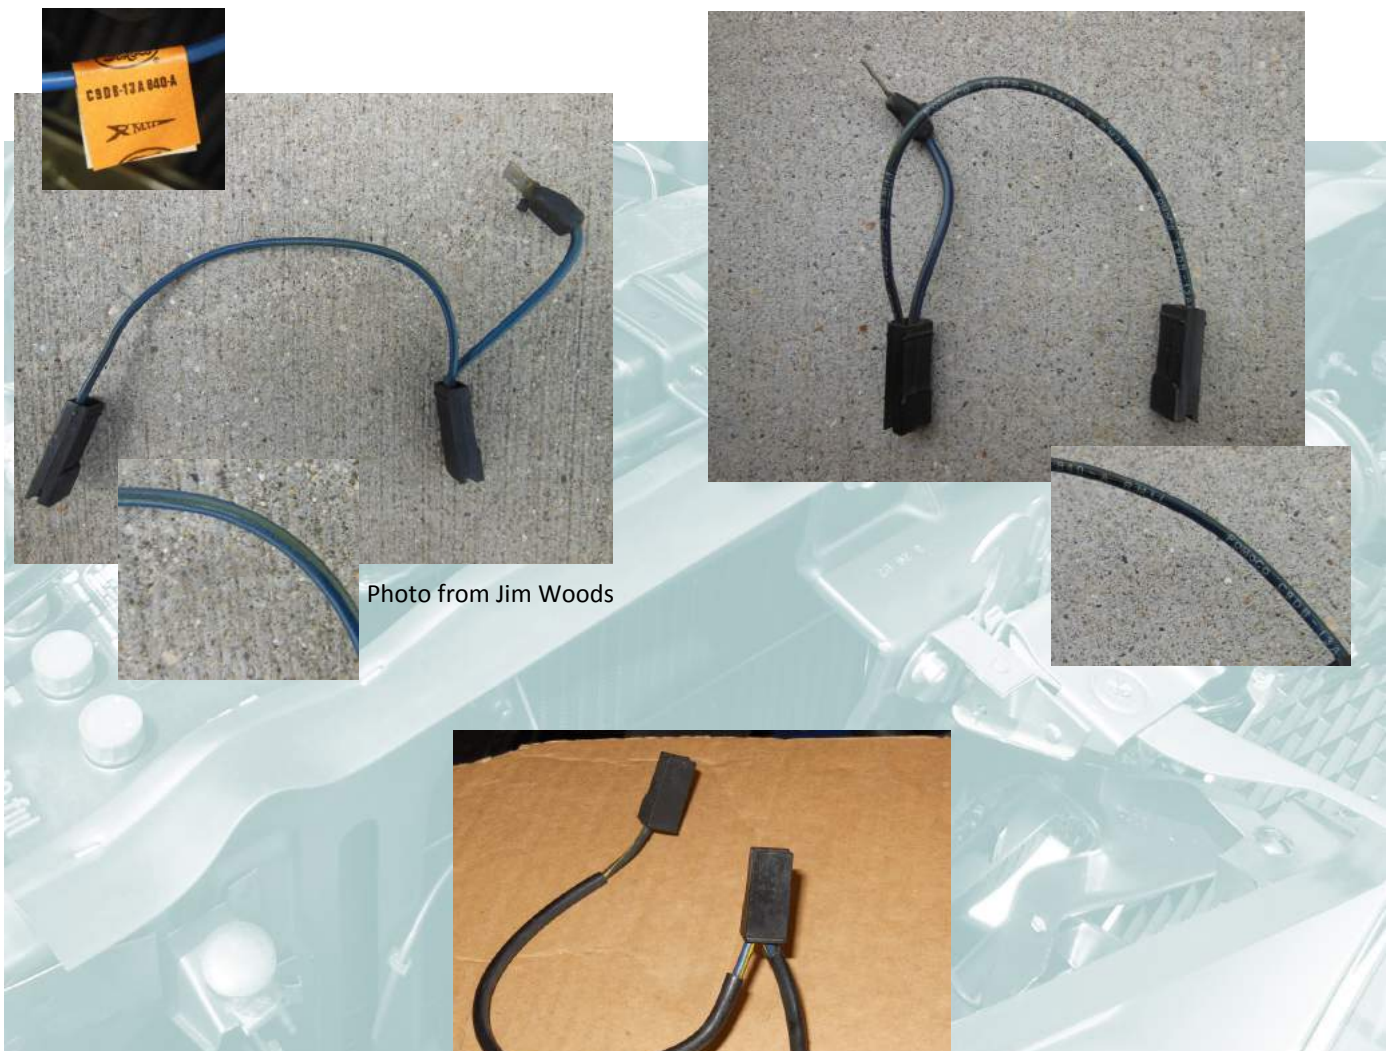
Horn Jumper Wire: A special jumper wire was used to connect the two horns together from the same contact point of the main wiring harness. Two basic versions of this wire existed in which one was blue with a yellow stripe and the second was blue with the engineering number printed on the wire as C9DB-13A840-A. It is believed that a paper tag was only applied to the wire without the printing to identify it since the printed version already had the engineering number.

Third possible version (yet to be confirmed) that is the yellow stripe wire with a sheathing added on the wire (Courtesy of Brian Conway).

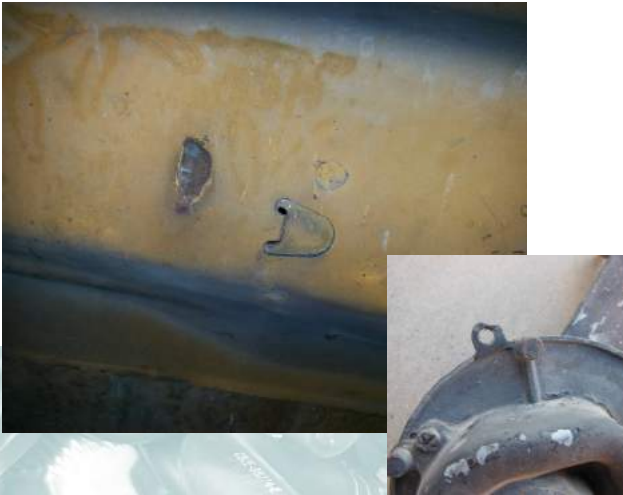
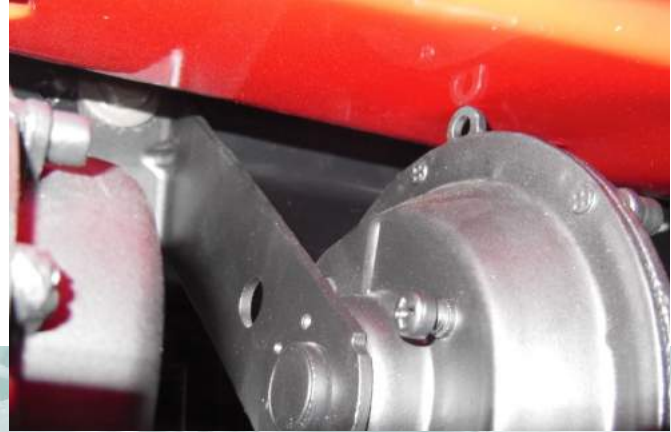
Mounting with oil cooler 69 vs 70: The mounting location of the horns was changed from 1969 to 1970 because of clearance issues. When moving the Hi pitch horn to the passenger side there is a tab that could rub against the hood as shown here causing damage to the hood and the horn. On some horns you can actually see this tab bent or worn down.

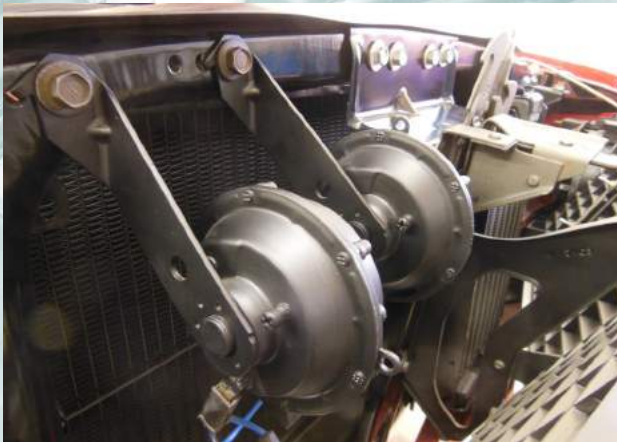
1969 Installation—Click to enlarge

To overcome this clearance issue the position of the two horns was actually switched at some point into 1970 production. This eliminated the horn tab rubbing up against the hood. Interestingly, for the oil cooler option location only, the assembly manual shows the bolts being mounted from the front of the radiator support in 1969, and then shows them mounted from the rear in 1970. See photos here below.
