1965 to 1973

Rear Tie Down Brackets

M A R C U S A N G H E L

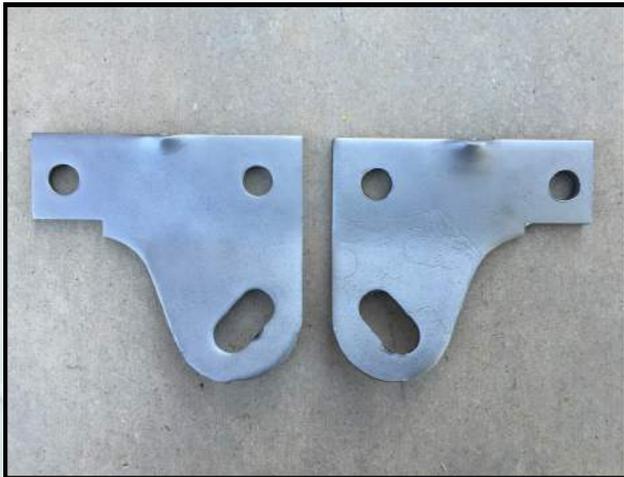
Version A with indexed notch

All single exhaust Ford Mustangs and all Mercury Cougars (regardless of engine option) used the smaller tie down brackets attached to the rear frame rail (**Note exception mentioned on last page). Shown here there is a defined left and right side bracket with two different versions shown. Version A has an indexed notch that was possibly there to avoid the bracket being installed backwards. Version B does not have this indexed notch.

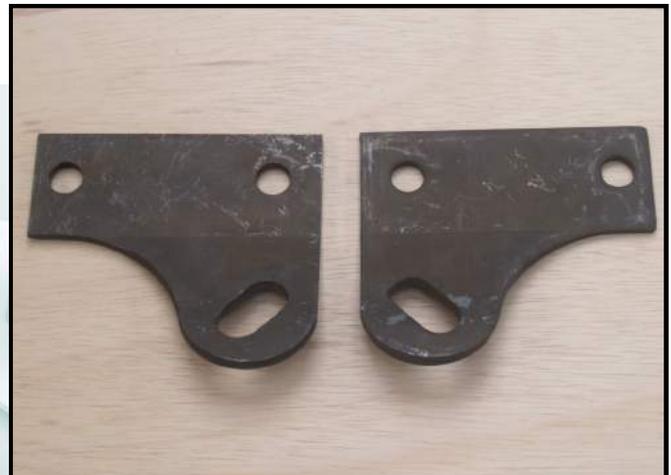
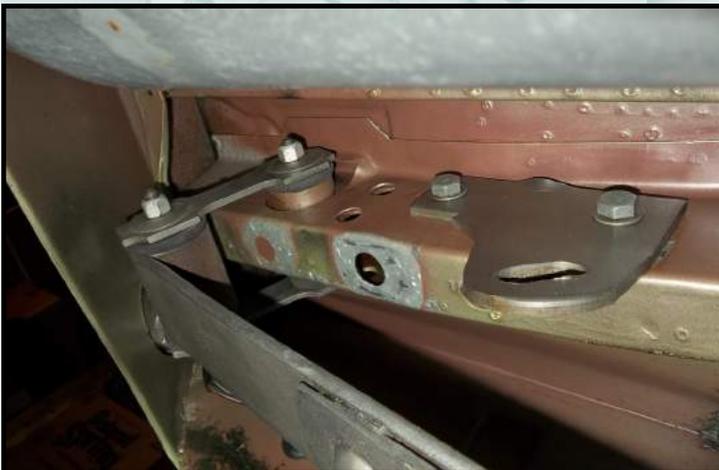
Version B without indexed notch

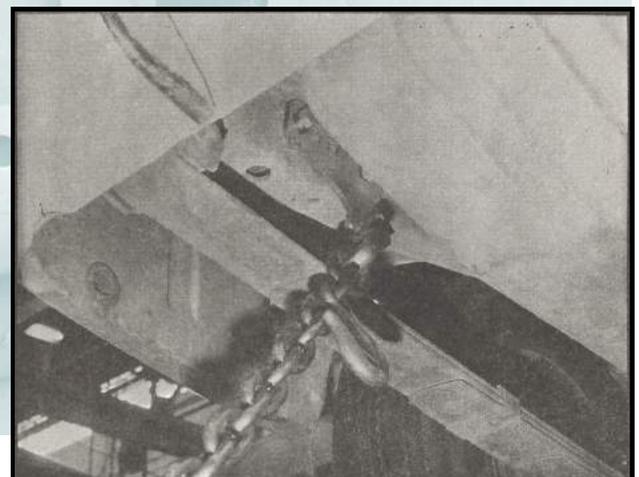
Picture here shows drivers side rear tie down bracket installed and original tie down procedure in place with T hook and chain.

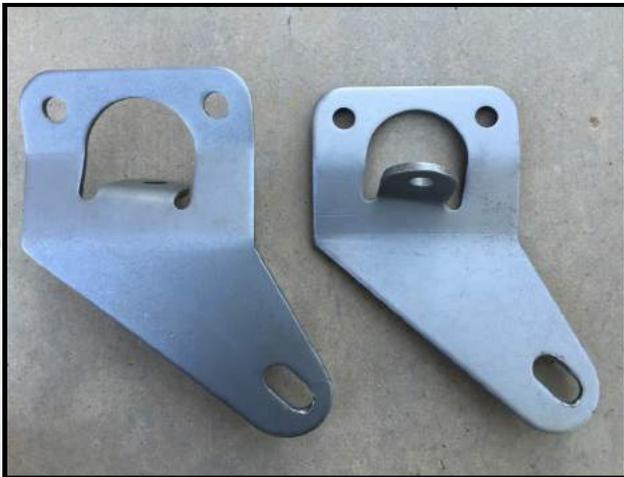
Version A: Commonly referred to as the Dearborn version with rounded edges it appears this version has mostly been found on Dearborn and Metuchen cars and normally seen as bare steel.

All dual exhaust Ford Mustangs (regardless of engine option) used the larger tie down brackets attached to the rear frame rail (**Note exception mentioned on last page). Shown here are two versions of this bracket.

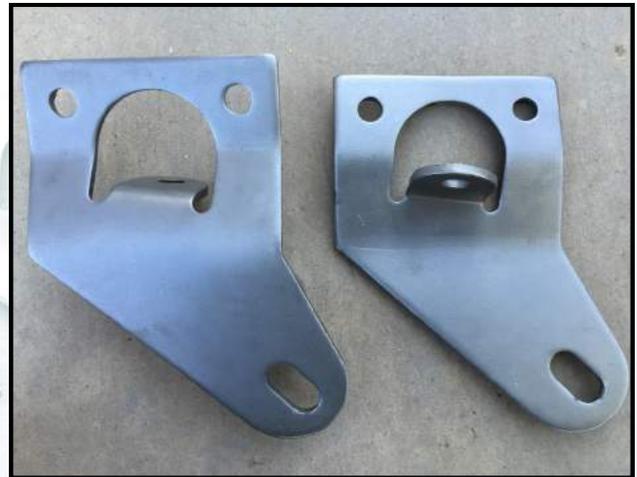
Version B: Commonly referred to as the San Jose version with squared edges this version has mostly been found on San Jose cars and seems to have been painted black from the factory before installation.

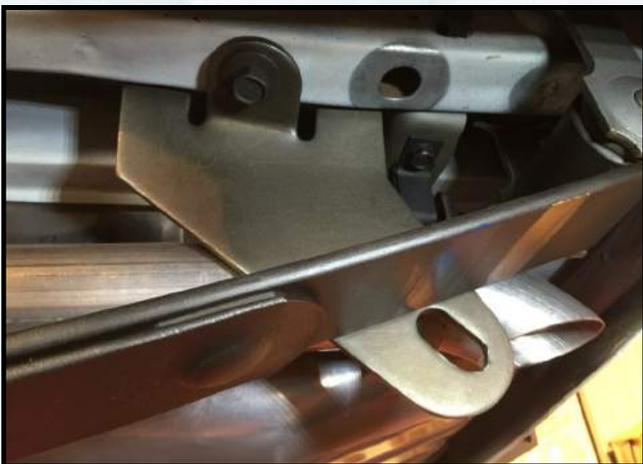
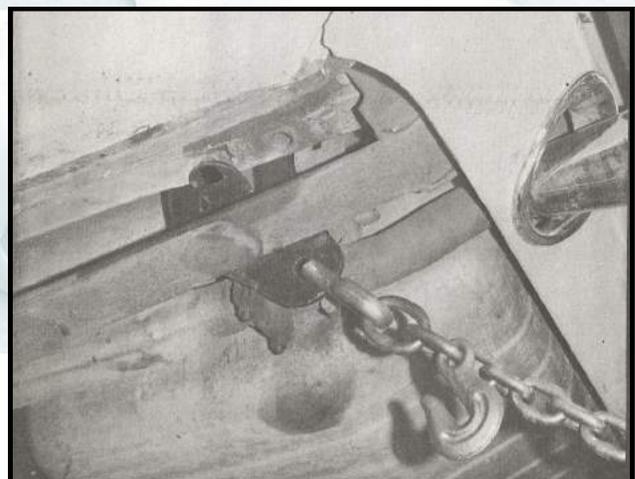
Picture here shows drivers side rear tie down bracket installed and original tie down procedure in place with T hook and chain.

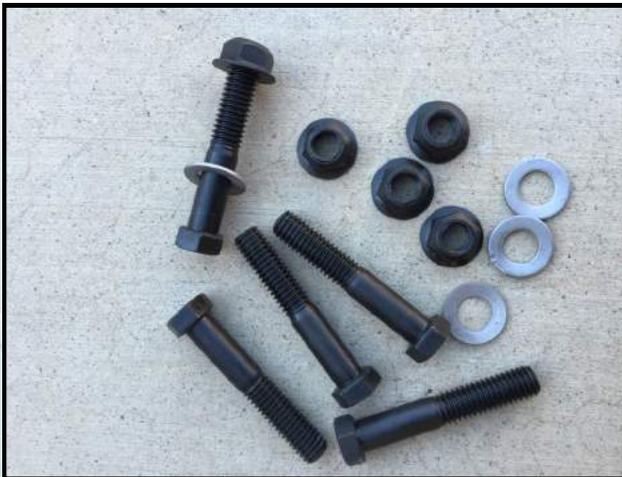
Bolts with separate washers typically seen on San Jose cars.

As with the different versions of tie downs, two different versions of hardware were used to attach the brackets to the frame. One version had a captive washer and the other had a separate washer. The dual exhaust cars would typically have two extra bolts added to the bottom of the frame.

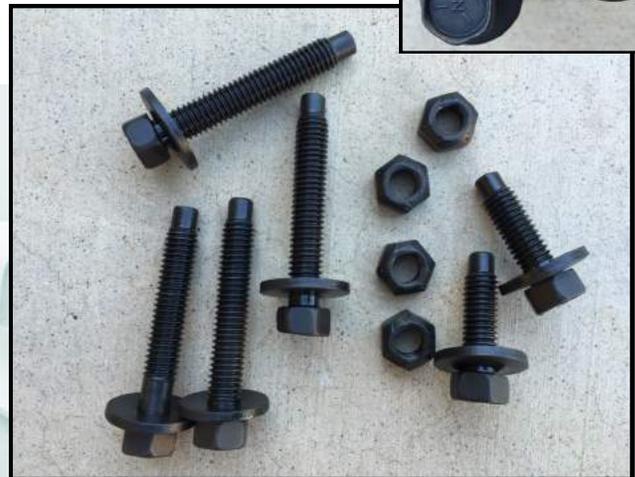
Bolts with captive washers typically seen on Dearborn and Metuchen cars.

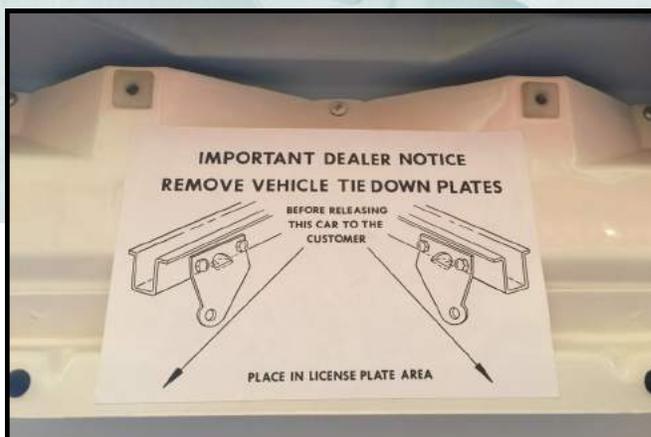
1628 1969 MUSTANG REAR SHIPPING TIE-DOWN PLATE REMOVAL (1969 Mustang's With Dual Exhaust System)

The large rear shipping tie-down plates, used on 1969 Mustang passenger cars equipped with dual exhaust systems, must be removed from these vehicles before vehicle is delivered to the customer. The shipping plates interfere with the rear spring shackles and exhaust system.

Reminder Stickers are attached and will continue to be attached to the rear of these cars as an additional reminder to assure dealer removal of the shipping plates before the vehicle is placed in operation.

The small rear shipping tie-down plates used on Mustang passenger cars with single exhaust systems provide no interference and do not need to be removed from these ve-

As part of the dealer prep the tie down brackets were to be removed from the car prior to delivery to the customer. The factory placed a sticker in the rear license plate area to remind dealers to remove the brackets. Interestingly, these stickers have been found not only on dual exhaust, but also single exhaust cars. There has been discussions that the dealers were given a refund for each bracket removed and returned to Ford, but as of today no documentation has ever been found to support this.

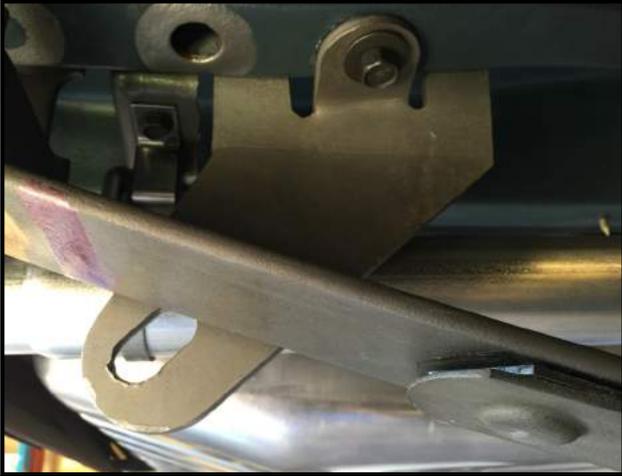
Dearborn style

Length: The “Dearborn” and San Jose” dual exhaust brackets are actually slightly different lengths. Pictures here show the difference when installed on the same car on the passenger side for comparison.

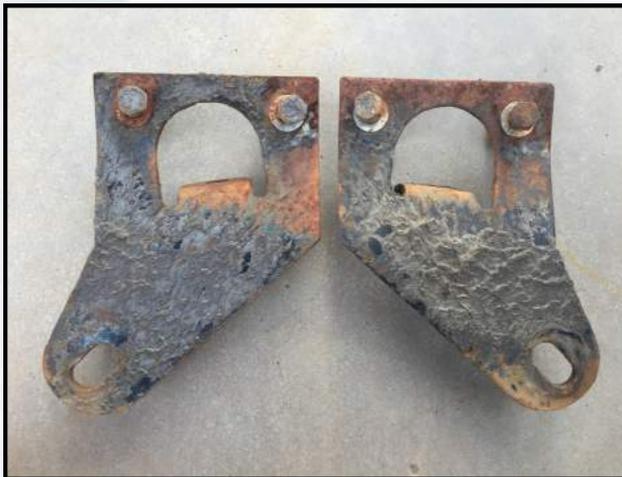
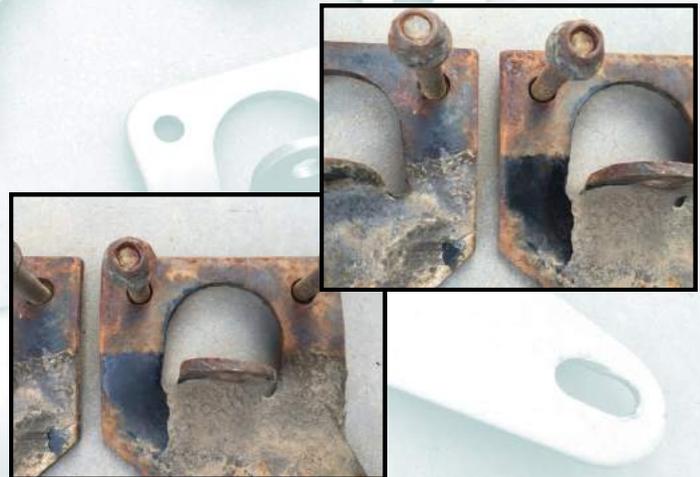
Black Paint: The original tie down brackets used in San Jose appear to have been painted black before installation. Here you can see an original pair that has been pulled off a car with black paint underneath.

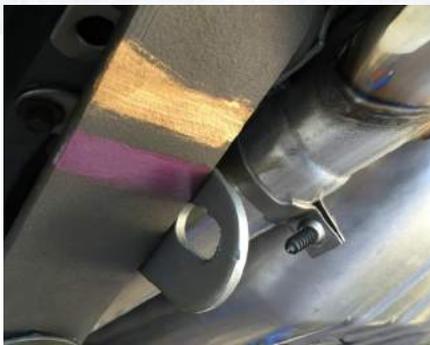
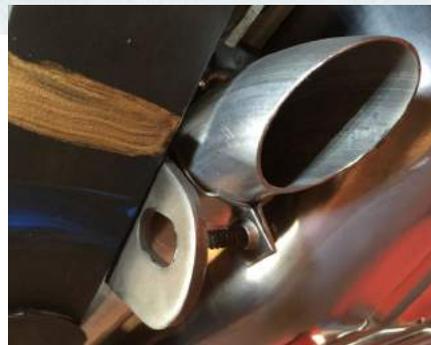
Interference Issues: Here you can see potential interference issues with dual exhaust tie down brackets and the rear springs, shackles and the exhaust system when installed. The main reason for the recommended removal.

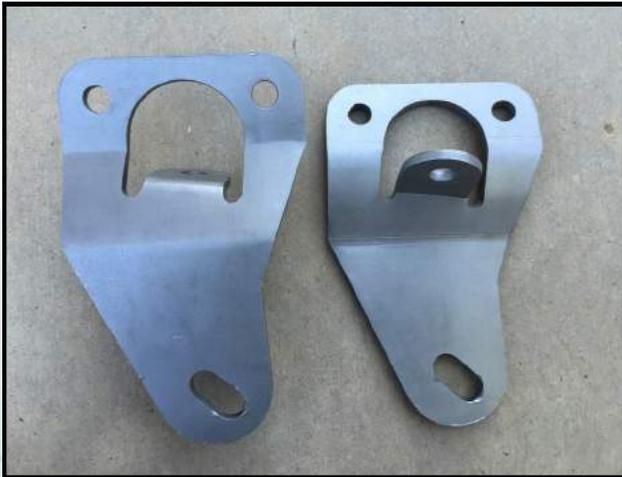
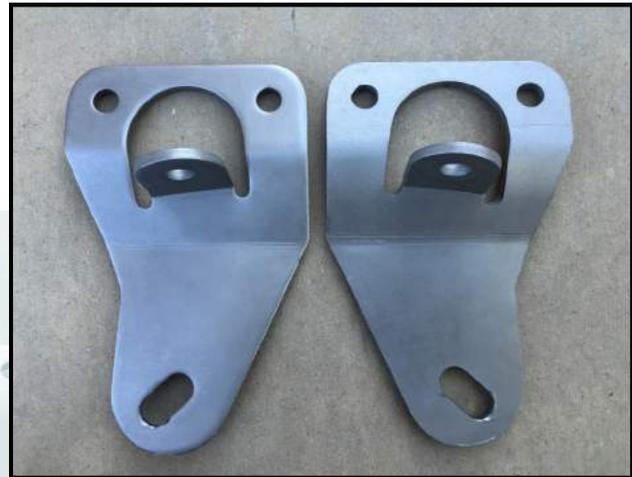
Ford Maverick and Mercury Comet:** The only other tie down bracket that looks similar to the Mustang dual exhaust brackets, but with a slightly different shape. These are often mistakenly sold as Mustang tie down brackets.

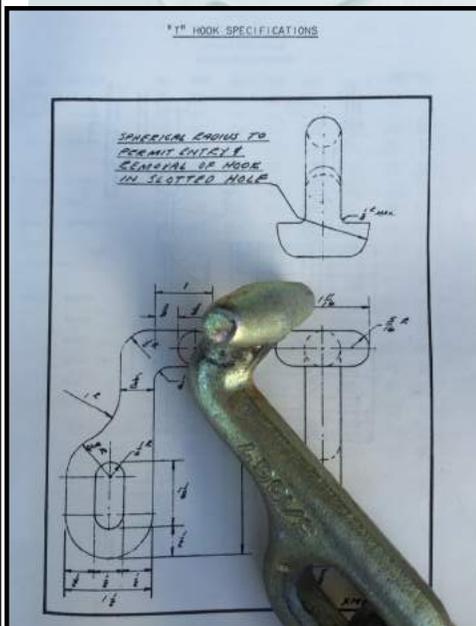
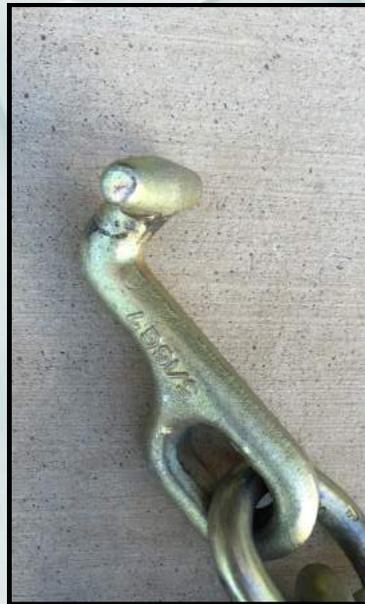
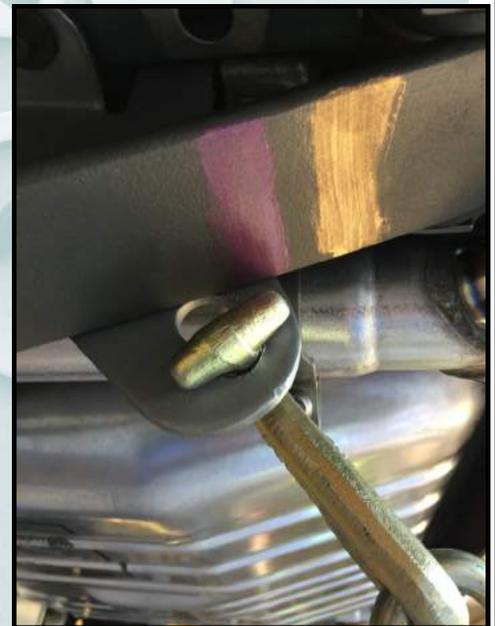
T Hooks: Pictures here of the T hooks that were originally used in the tie down bracket slots and as would be installed during transport.
